FIRST REPORT

RE: Name Insured : J&J Properties Partnership

dba: Suburban Shopping Center

Loss Locations : 4201, 4130 & 4128 North 1st

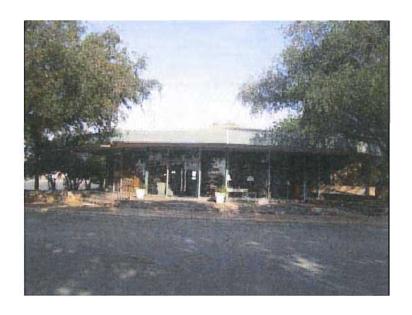
1 100_6885

01/01/2006 risk 4130 N 1st St.

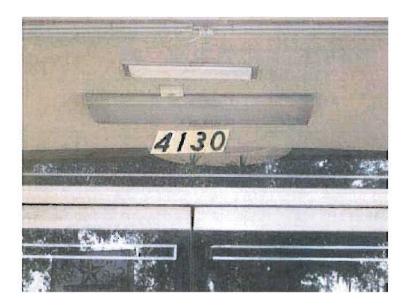
01/01/2006 address verification

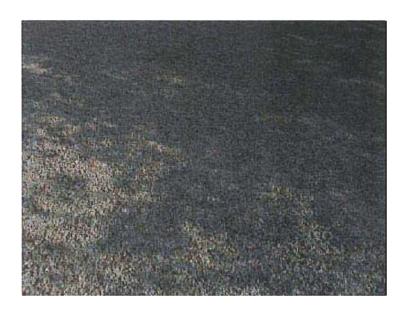
5 100_6889

01/01/2006 gravel roof not damaged

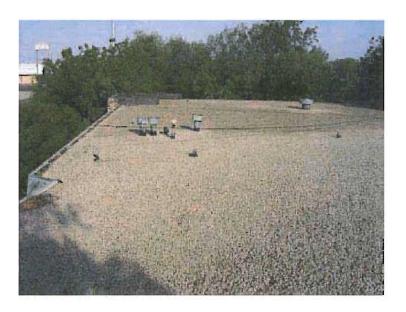
01/01/2006 view toward rear of roof

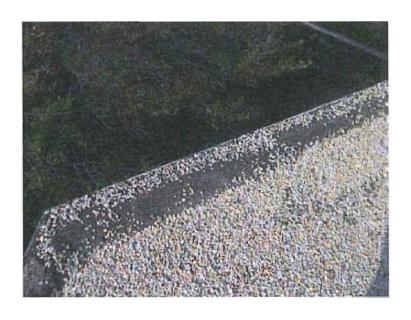
7 100_6891

01/01/2006 rear end of roof perimeter is built up

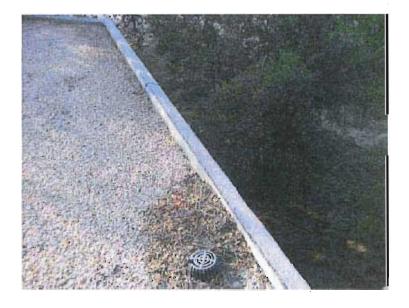
01/01/2006 perimeter not damaged

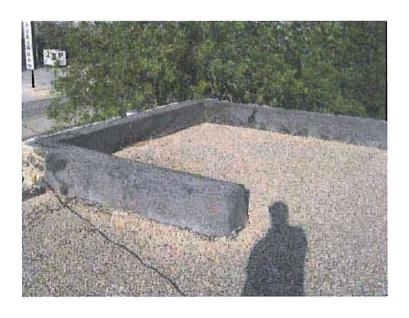
100_6893

01/01/2006 raised square

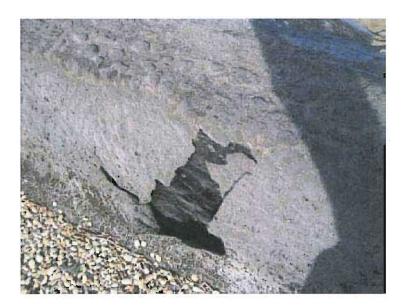
10 100_6894 01/01/2006 parapit wall is worn

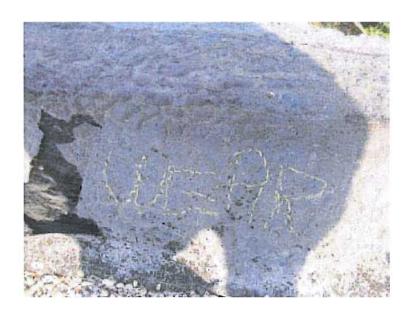
11 100_6895

01/01/2006
parapit coping is worn

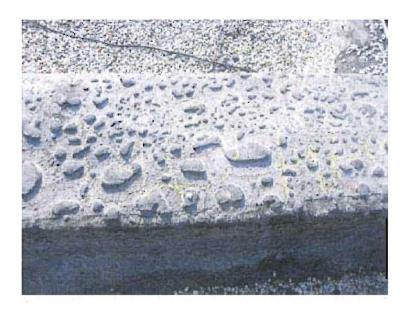
01/01/2006 top view of wall

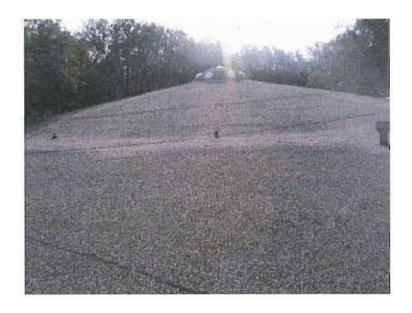
13 100_6897

01/01/2006 extended view of roof

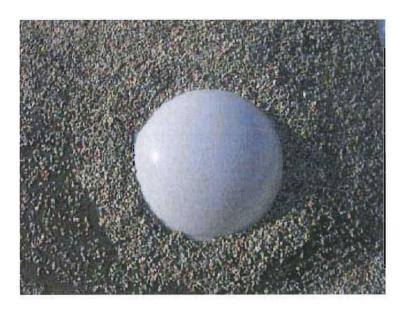
14 100_6898

01/01/2006 skylight no damage

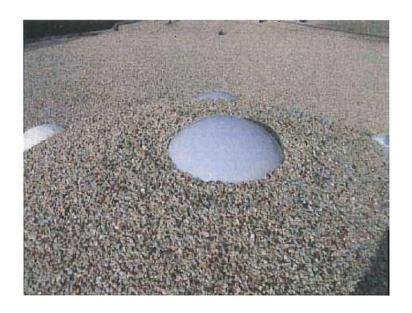
15 100_6900

01/01/2006 skylights on dome not damaged

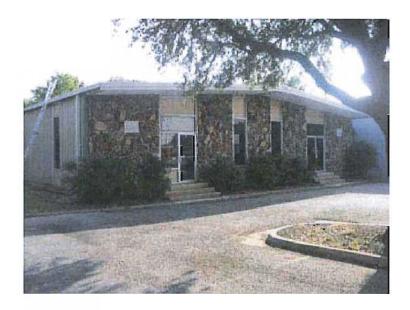
16 100_6905

01/01/2006 risk- 4128 N 1st St.

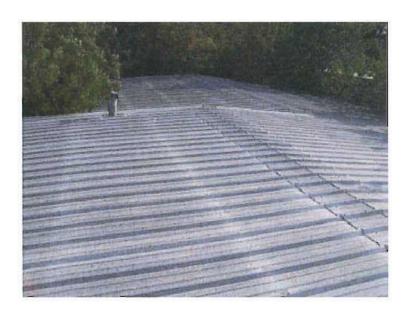
17 100_6906

The metal roof panels are made of 24 gauge material. There are no signs of hail damage on the roof and perimeter walls.

01/01/2006 roof overview- metal

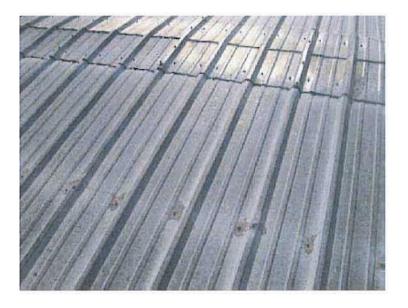
01/01/2006 metal roof not damaged

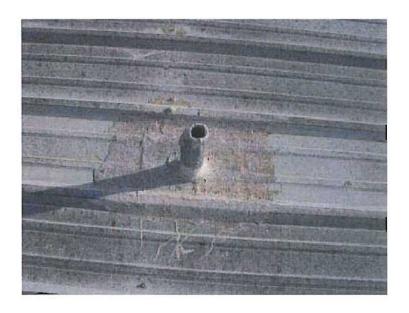
19 100_6908

01/01/2006 roof jack not damaged

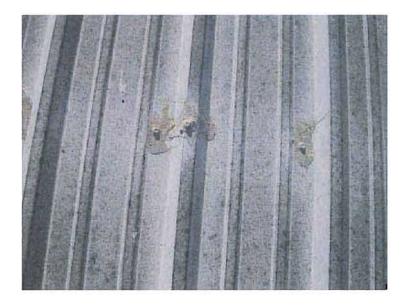
20 100_6909

01/01/2006 roof screws covered to prevent leaks

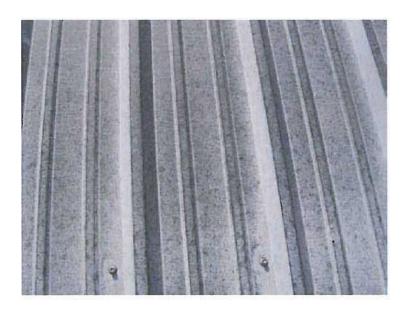
21 100_6910

01/01/2006 closer view no damage

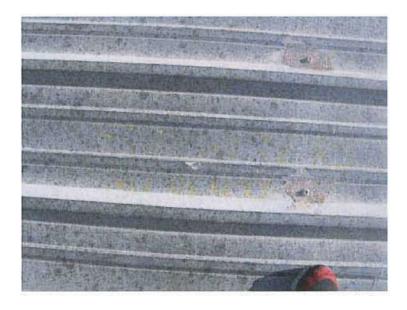
22 100_6911

01/01/2006 no damage

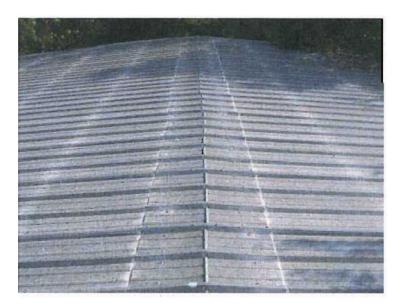
01/01/2006 ridge overview- no damage

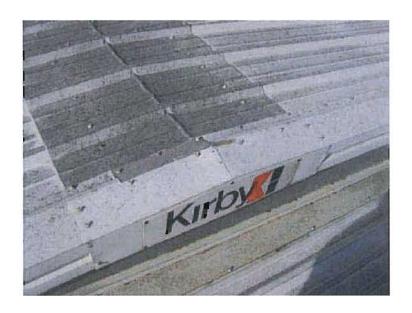
25 100_6914

01/01/2006 roof brand

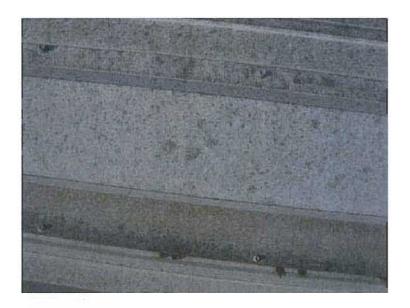
01/01/2006 eave not damaged

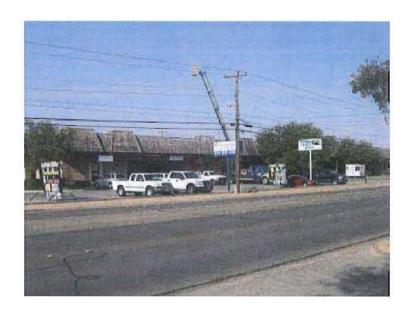
27 100_6916

01/01/2006 4201 N 1st St.

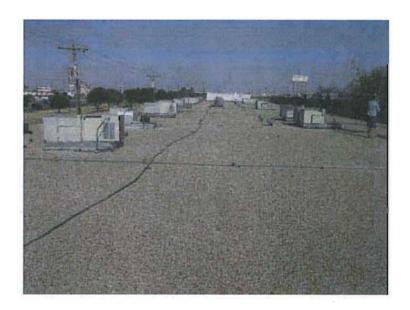
28 100_6917

The flat roof with gravel overlay has no signs of hail damage.

01/01/2006 roof overview- gravel

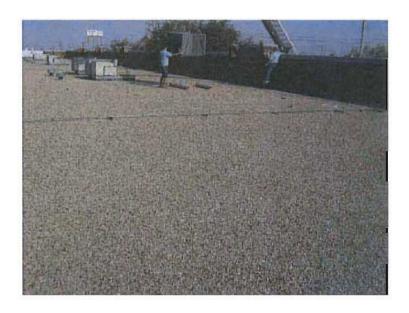
29 100_6918

01/01/2006 new a/c units being installed

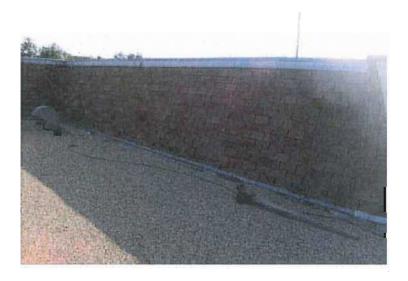
30 100_6919

The flat roof with gravel overlay showed no signs of hail damage. The front façade/mansard is made of wood shingles. There was no visible damage found on the wood shingles. The parapet wall is covered with three tab composition shingles. There were no signs of hail damage on these shingles. We did see that the composition shingles in some places on the parapet wall are sliding down due to improper installation. This was not wind damage, but actual sliding has occurred to some of the shingles.

01/01/2006 parapit wall- comp shingles

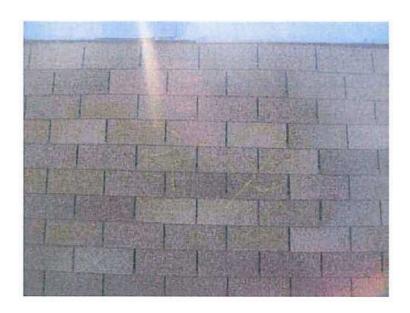
31 100_6921

01/01/2006 wall on east end no hail damage

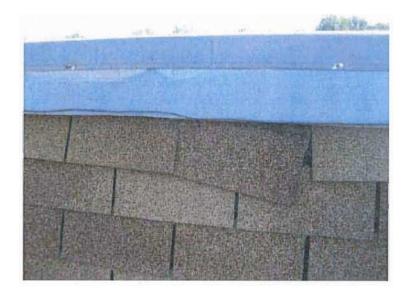
01/01/2006 shingles sliding from wall

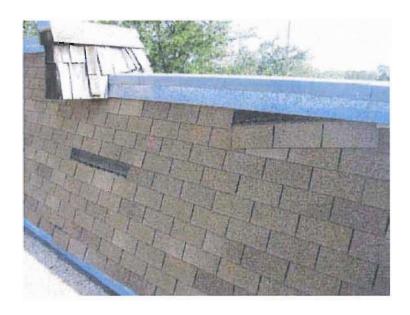
33 100_6923

01/01/2006 sliding shingles not loss related

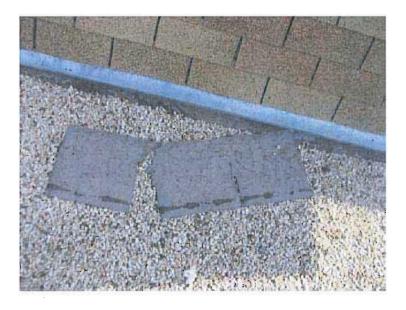
01/01/2006 fallen shingls from slide

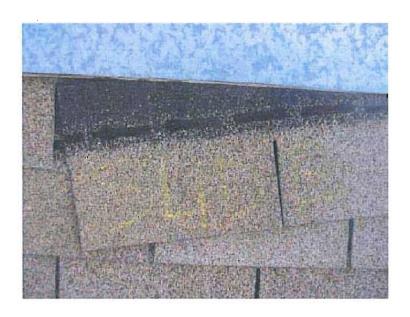
35 100_6925

01/01/2006 slide

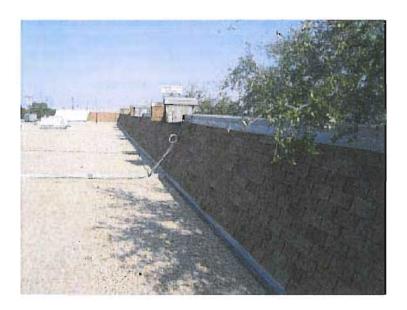
01/01/2006 north wall overview

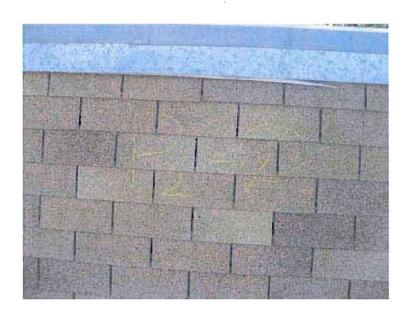
37 100_6927

01/01/2006 no hail damage

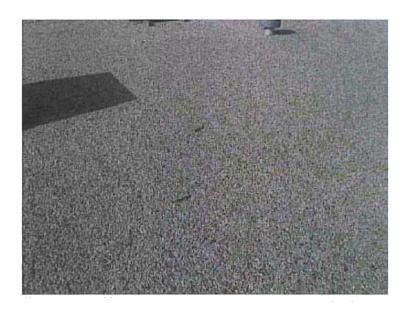
38 100_6928

01/01/2006 gravel roof no damage

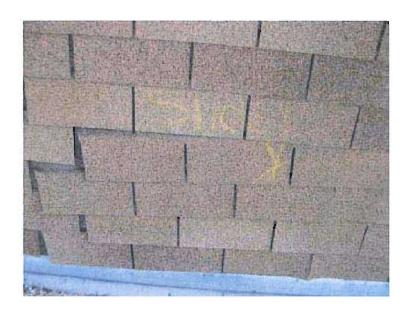
39 100_6929

01/01/2006 more slides

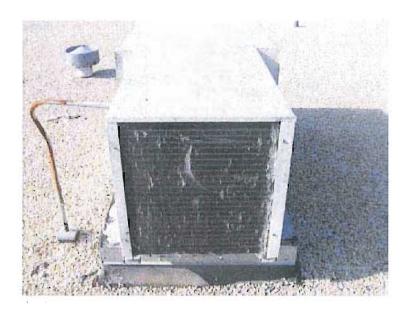
40 100_6930

a/c unit no damage

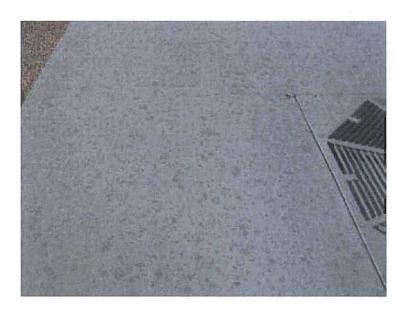
41 100_6931

01/01/2006 pea size marks on a/c unit- no dents

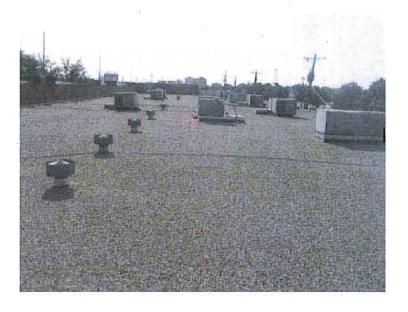
01/01/2006 extended overview
